DIAGNOSIS

Work definition

GOAL OF INTERVENTION

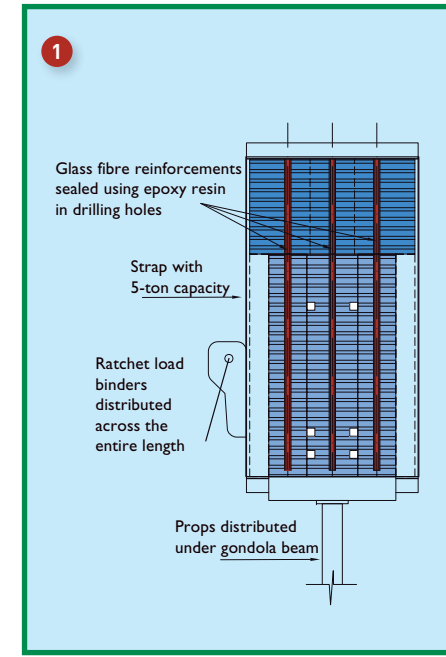
REINFORCEMENT OF GONDOLA BEAMS

After strutting the gondola beam at soffit and removal of lateral wood siding:

- Condition of wooden parts are inspected
- Deteriorated parts are removed and treatments are applied

After loosening the bolts of the central iron work, the prosthesis made of glued-laminated wood is set in place perpendicularly under the corresponding gondola beam:

- Prior to setting in place, surfaces are sanded and RENOFORS resin is applied
- Elements are adjusted and compressed by tightening straps distributed across the entire length of the gondola beam
- Prosthesis is pinned together by drilling holes and mounting glass fibre rods sealed with RENOFORS resin

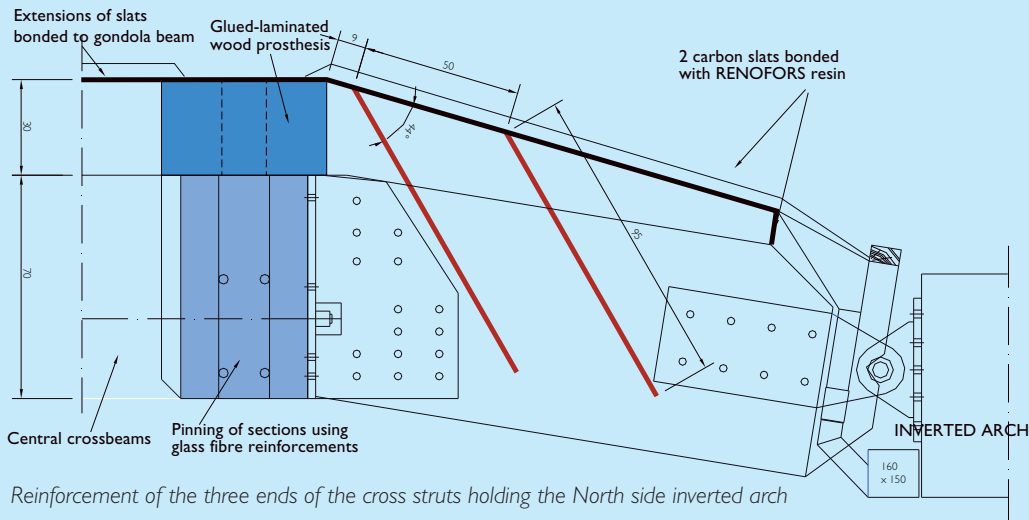
Moreover, the North side inverted arch of the structure was showing signs of significant sagging causing a transfer of the loads to the first gondola beam with a twisting and punching effect on the base of the beam. It therefore was necessary to mount two resin-glued carbon slats to the initial prosthesis.
