DIAGNOSIS

Work definition

GOAL OF INTERVENTION

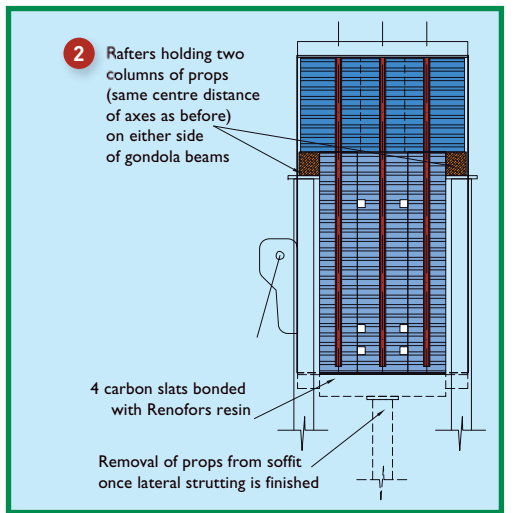
Once these elements have been made interdependent, lateral props are put in place in order to allow the removal of the initial props at soffit:

- Carbon slats are mounted by bonding with RENOFORS resin and compressing the whole
- Finally, bolts of central iron work are tightened again, central node is treated with resin concrete and siding flanges are mounted back in place.
